Surface pathology on the walls of limestone and mortar masonry

Abstract

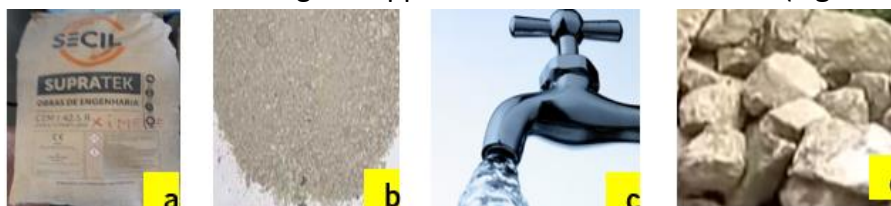
Figure 3. Materials use in the construction:
 a) cements, b) sand, c) water and d) stones

As shown in Fig. 3a shows some cements manufactured in Portugal. It is widely used in general for buildings that do not have specific requirements, such as houses, tall buildings, bridges, roads and highways.

The fine aggregates (**Figure 3b**) were duly used as natural sands for laying mixtures. Aggregates can be called fine (larger particle size less than or equal to 4 mm) or coarse (larger particle size greater than or equal to 4 mm and smaller particle size greater than or equal to 2 mm).

An important factor is the origin of the water used. According to IPQ (2003) in their number of the NP EN 1008, they have governed the application of liquid in concrete and made considerations regarding the origin of the selected water (**Figure 3c**).

The stones used in the construction are porphyry granites, basalt, limestone, sandstone, shale and marble. These materials have great application in civil construction (**Figure 3d**).

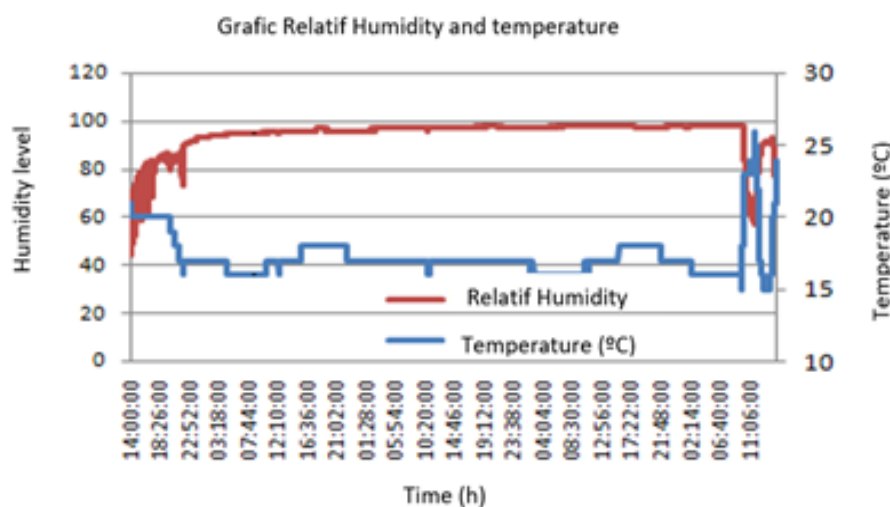
Figure 5. Graph of humidity and temperature of water absorption by capillarity

For the knowledge of some phenomena existing in the absorption, a probe was used to monitor the temperature, and the relative humidity of the test specimens inside the box. As can be seen in (Figure 5), the probe presented the following results: the temperature in the range of 17°C to 23°C; the relative humidity with a range of 90 to 95%.

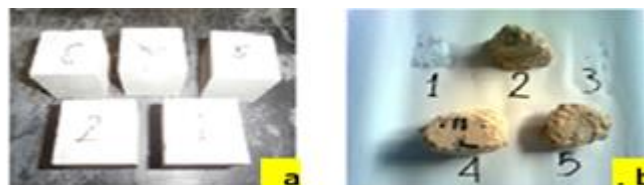
Figure 7. Visual result of tenth cycle by immersion in sodium sulfate solution

At the end of every five cycles the test pieces were washed with drinking water and remained in the oven for 5 days to obtain the constant mass. This mass is obtained after cooling the test pieces at room temperature (**Figure 7**).

After each period (five cycles) of immersion, the test pieces were observed in order to verify cracking, exfoliation, fragmentation, crumbling or any other type of alteration. At the end of the last immersion, the changes to the test pieces were noted.
