Recycling Potential of Onyx Composite for Additive Manufacturing

M. E. M. Mergulhão¹, S. G. Magalhães², J. M. Costa³

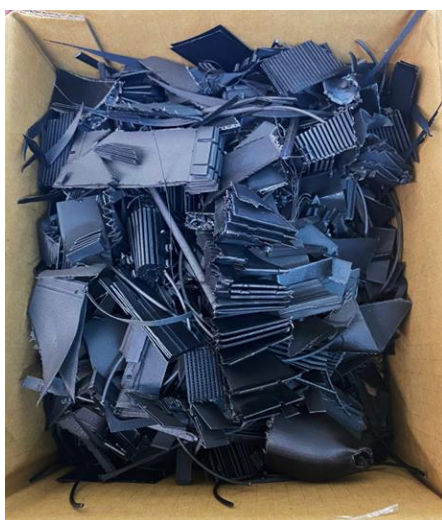
Figure 1: Diverse Onyx pieces that were used for recycling.

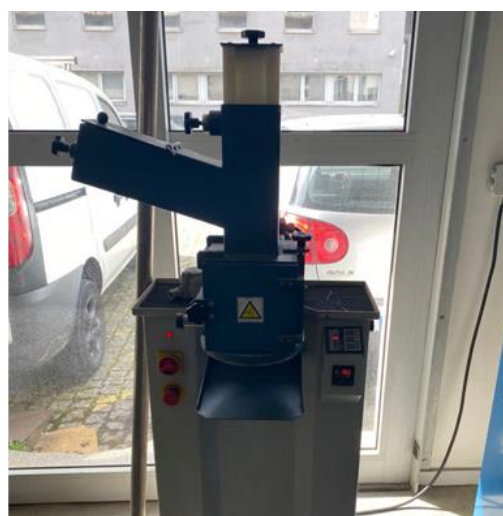
Figure 2: Mill Equipment.
